SERVICE LETTER – ATOM80

Oil leakage from the vent hole

AM04-ATOM80-003-SL_00 - Oil leakage from the vent hole

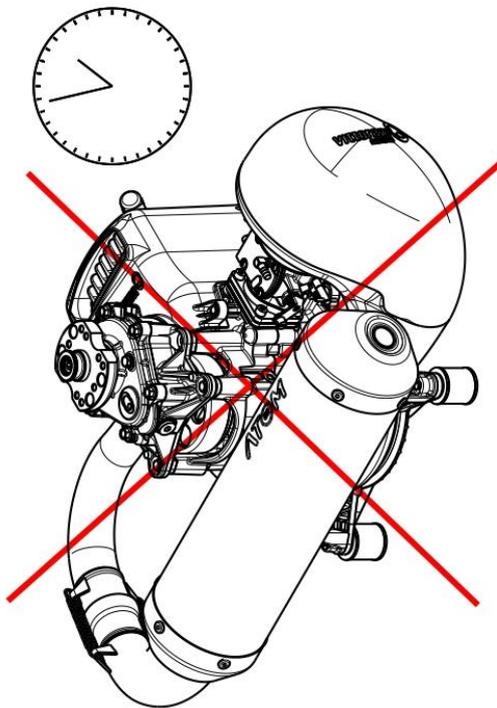
DON'T KEEP THE ENGINE HORIZONTAL (I.E.: PROPELLER PLANE HORIZONTAL) FOR MORE THAN 15 MINUTES

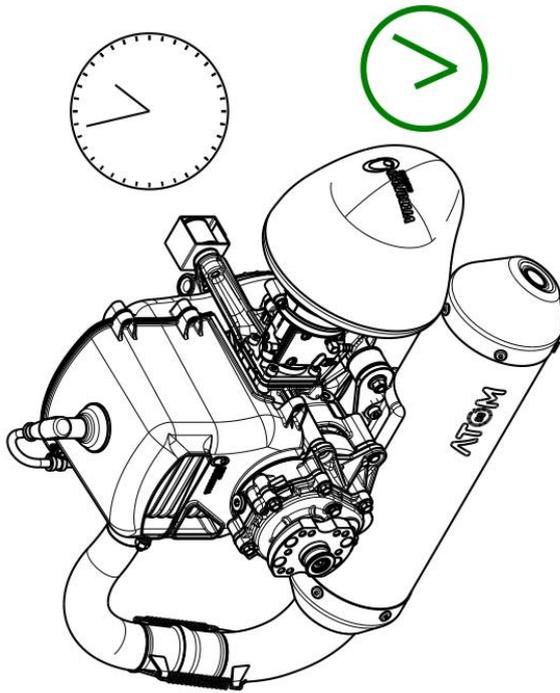
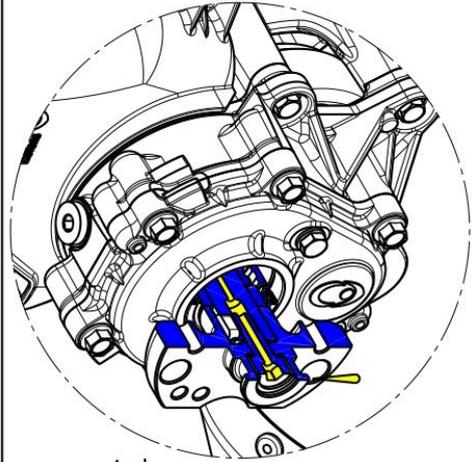
VENT HOLE
LUBRICANT

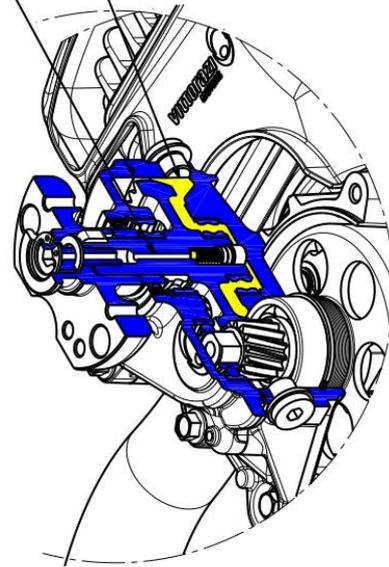
WRONG POSITION MAY CAUSE LUBRICANT INFILTRATIONS IN THE VENT HOLE AND CONSEQUENT LUBRICANT LEAKAGE
